NASA TECHNICAL NOTE

NASA TN D-563

INVESTIGATION OF S-IV ALL SYSTEMS VEHICLE EXPLOSION

Compiled and edited by J. B. Gayle

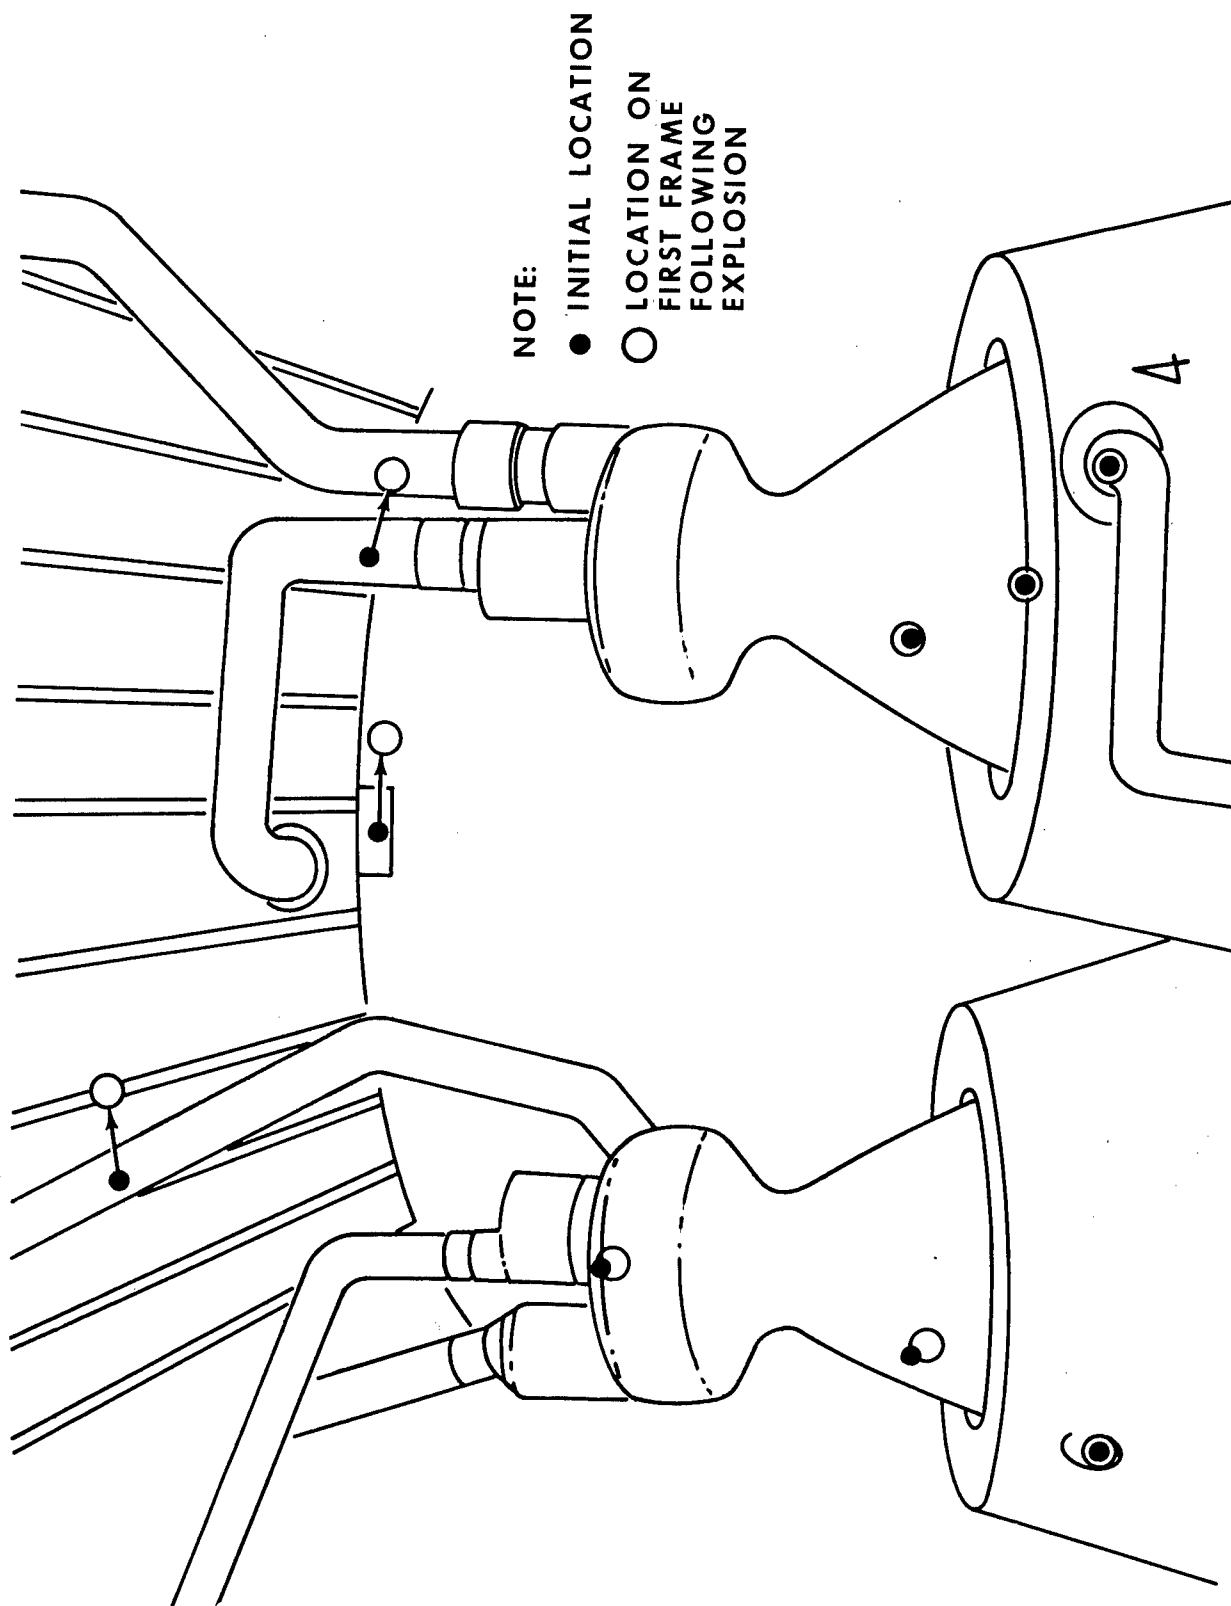
FIGURE 1. MOVEMENT OF VEHICLE AFTER EXPLOSION

Inspection of photographs prepared by enlarging individual frames from one of the engine area cameras indicated that the initial motion of the vehicle caused by the explosion had a definite westerly vector. This was determined by locating readily definable parts of the vehicle with reference to the test stand structure from photographs taken immediately before and after the start of the explosion. The results are shown in FIG 1. The movement from left to right shown in this figure represents movement in a north-west direction. Since this analysis indicates that the initial movement of the upper part of the vehicle was toward rather than away from the apparent center of the explosion, it appears that the principal explosion may have been preceded by a smaller one located near the periphery of the vehicle.

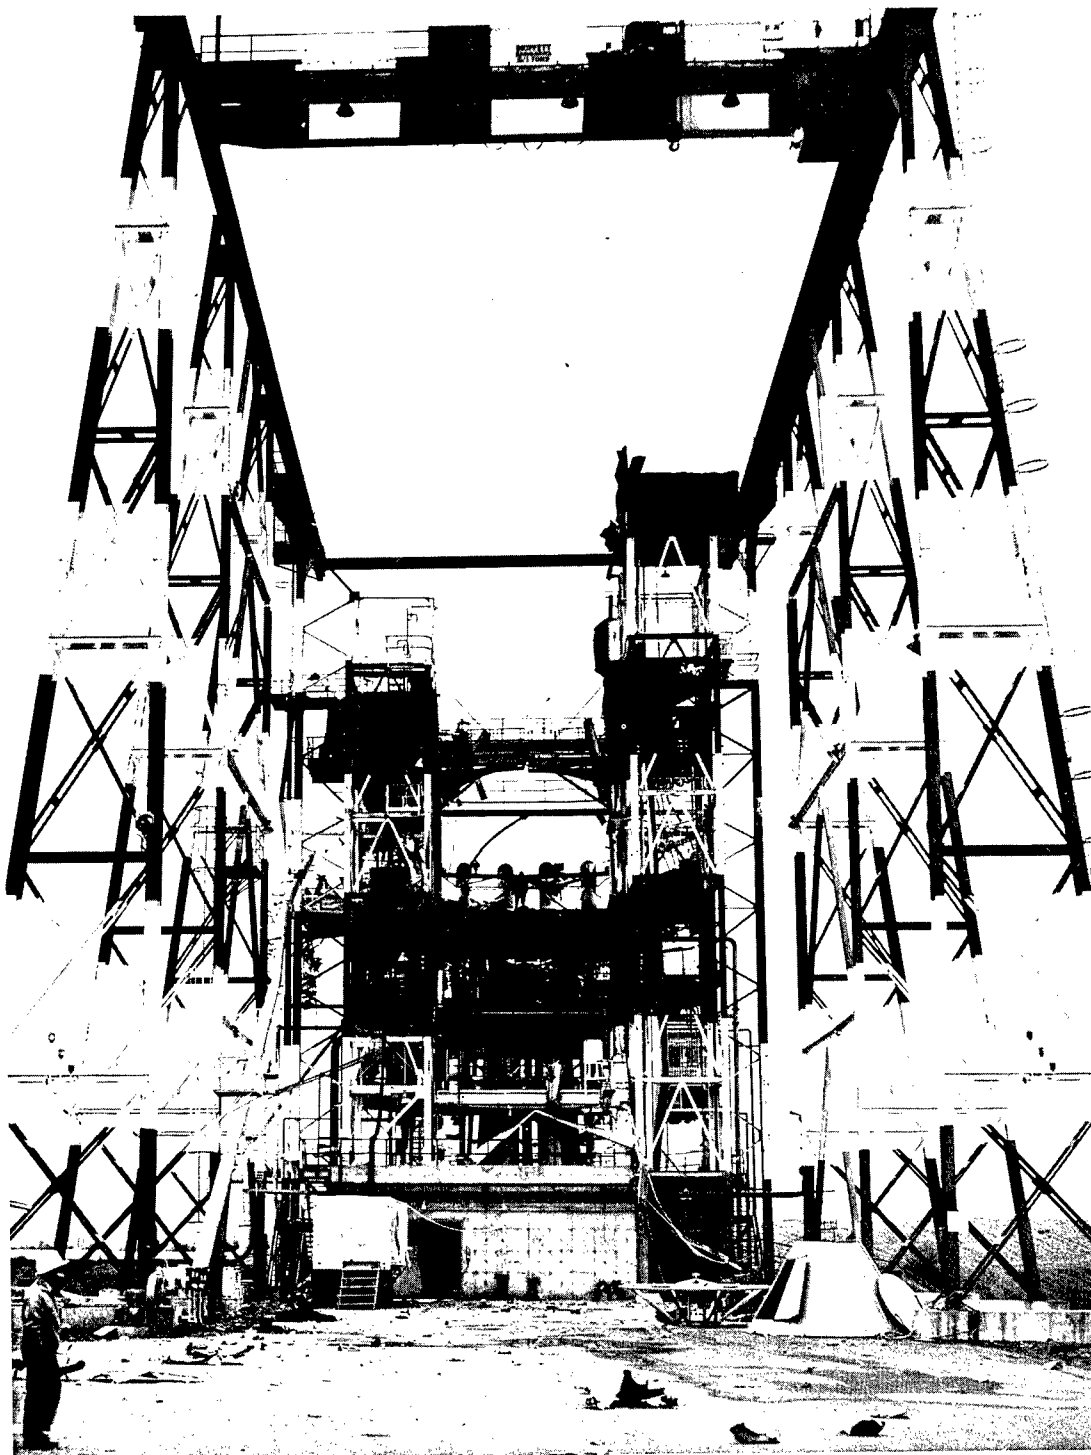
FIGURE 2. VIEW OF TEST STAND AFTER EXPLOSION

Figure 2 shows the test stand and vicinity after the explosion. Inspection of this figure indicates that the overhead crane and supporting structures were virtually undamaged and that the effects of the explosion were largely confined to the test stand proper.

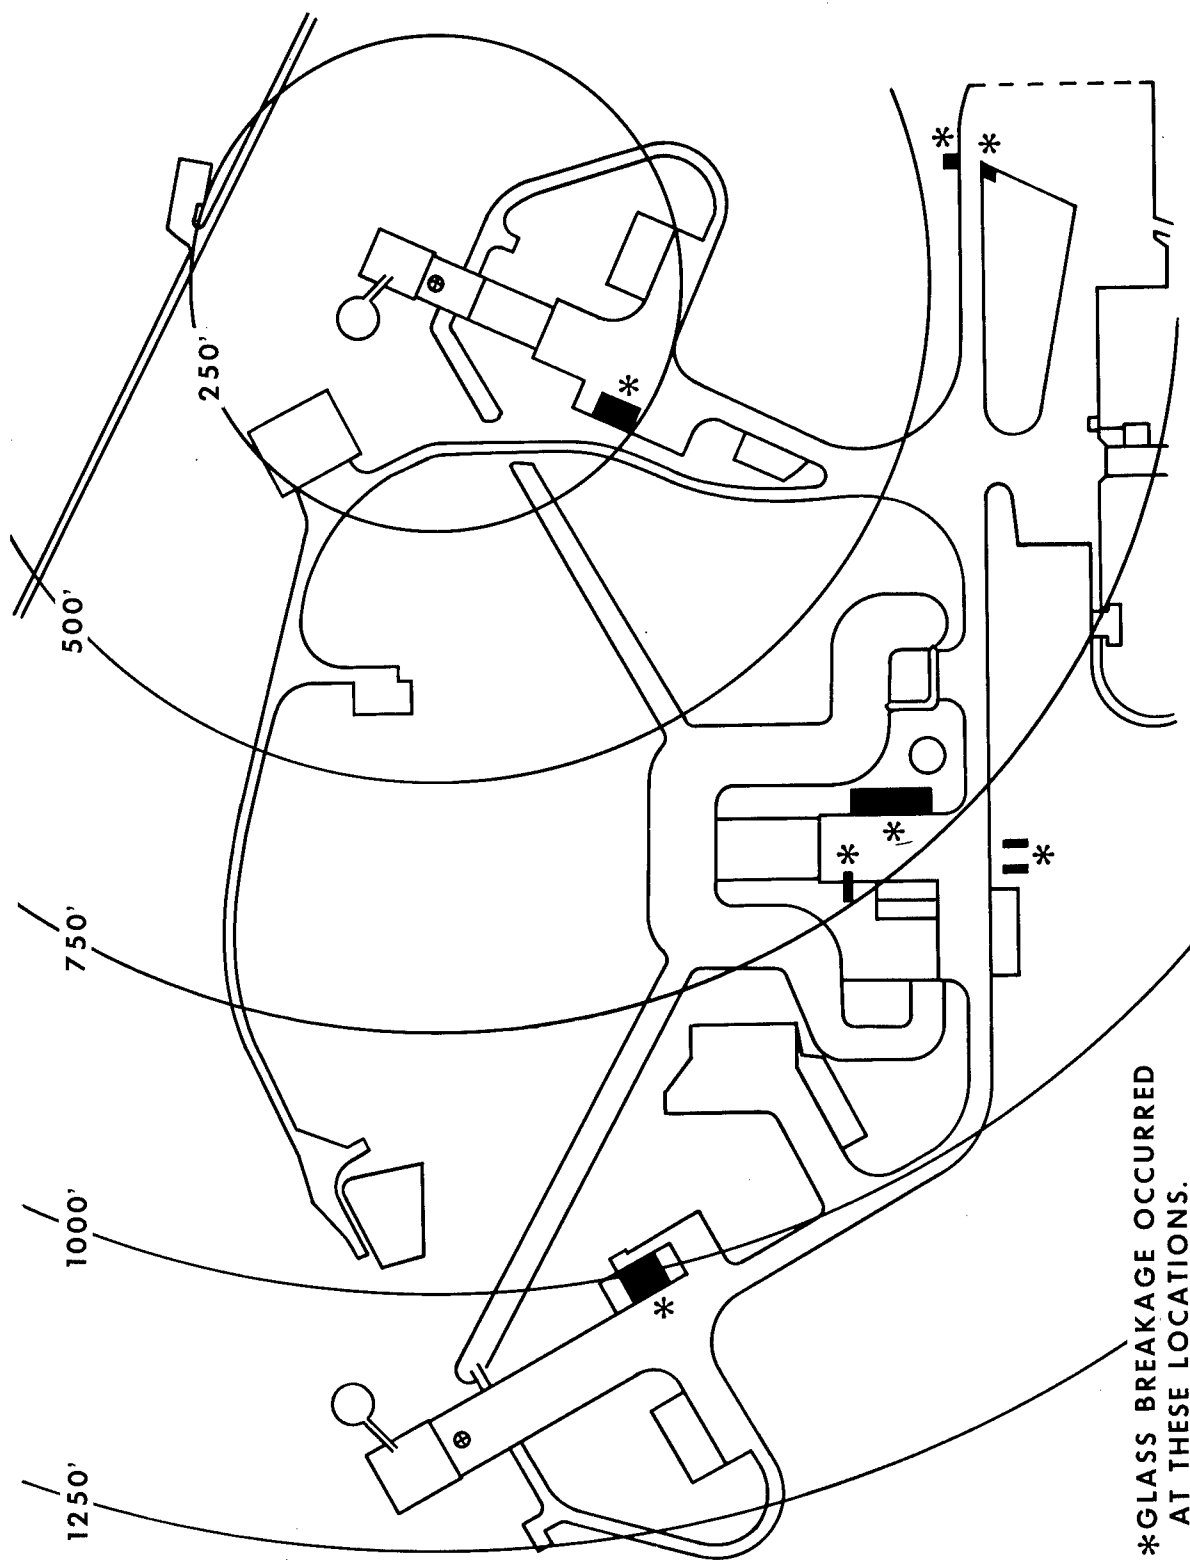
FIGURE 4. GLASS BREAKAGE PATTERN

Glass breakage occurred at distances up to approximately 1,100 feet from the center of the explosion, as shown in FIG 4. Most significant to this study were windows broken in guard shacks, house trailers, and Butler buildings.

a. All the window panes facing the center of the blast were broken in the guard house, 540 feet from the explosion.

b. Of the 18 panes in the pump house that were roughly in line-of-sight, six were broken, 700 feet from the explosion.

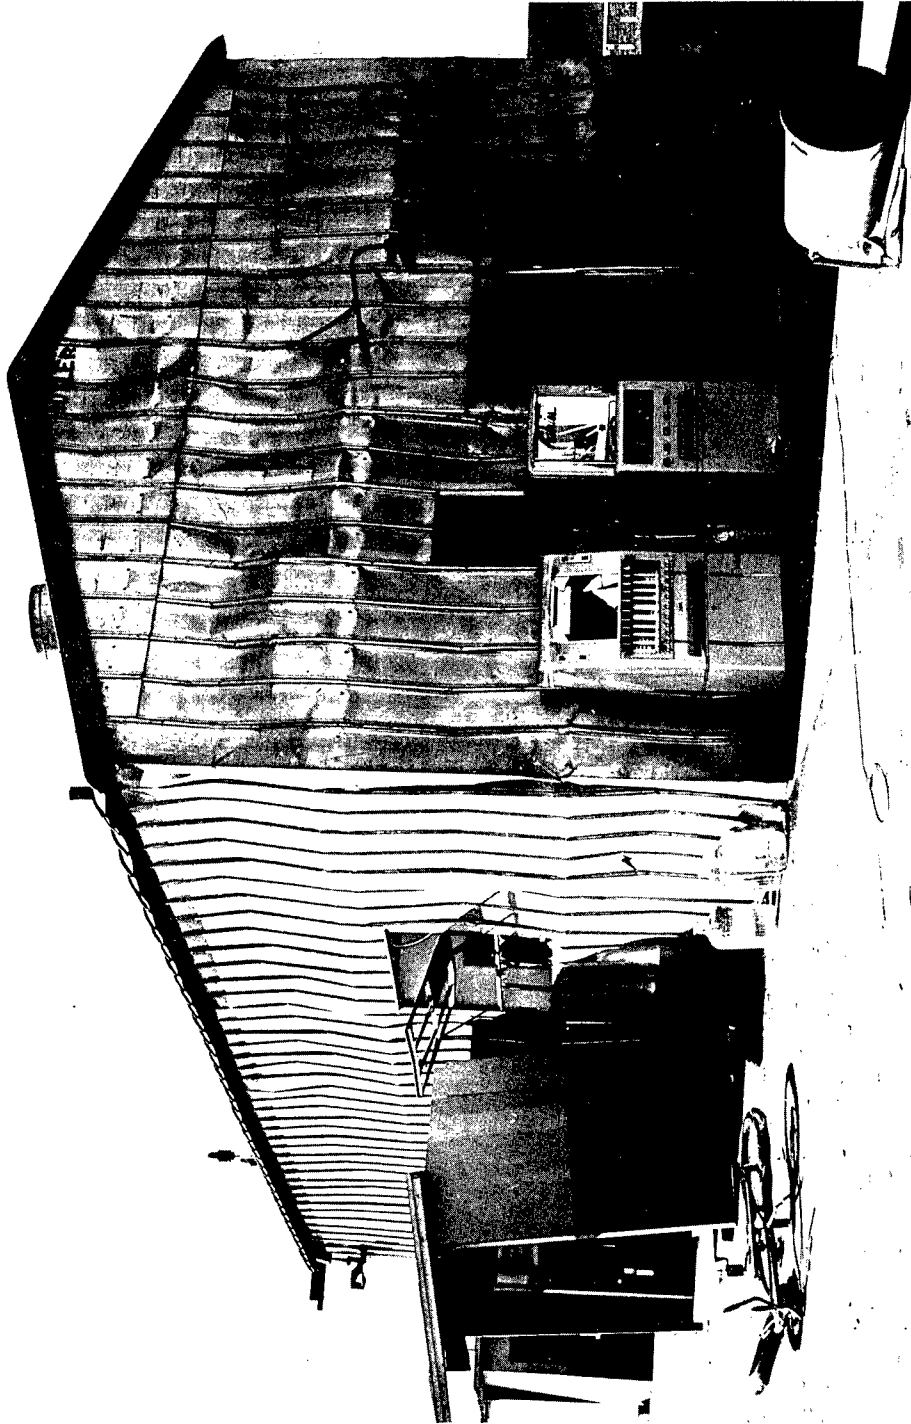
FIGURE 5. DAMAGE TO BUTLER BUILDING, TS-1

The Butler Building designated TS-1 suffered what we considered relatively light damage (FIG 5). One end of this building was positioned facing the blast, with the nearest surface at a distance of 210 feet from a point on the ground directly below the assumed center of the explosion. Damage to the test stand is described by individual levels.

This building was a lightweight sheet metal structure measuring 20' x 48' x 15'. It was positioned end-on to the direction of blast with the nearest end surface at a distance of 210 feet from a point on the ground directly below the assumed center of detonation.

Damage sustained by the Butler building was considered to be relatively light. The most extensive damage occurred on the end facing the blast, which would have been within the Mach stem. A general description of the damage would include a wrinkling to a slight crushing of the corrugated steel panels of from four to six inches in both the side walls and roof. Several windows were broken on the sides receiving the more direct blast, but only one was broken on either of the other two sides. Several structural members in the roof were slightly buckled or deflected a maximum of two inches while several others were loosened at the joints.

It has been assumed that a reflected overpressure of nearly five psi would be necessary at the near end of the building to produce damage of this extent from a relatively short (something less than 50 milliseconds) duration blast wave. The side-on overpressure at the near end of the building would then be approximately 2.5 psi and would require a high explosive weight of approximately 760 pounds.

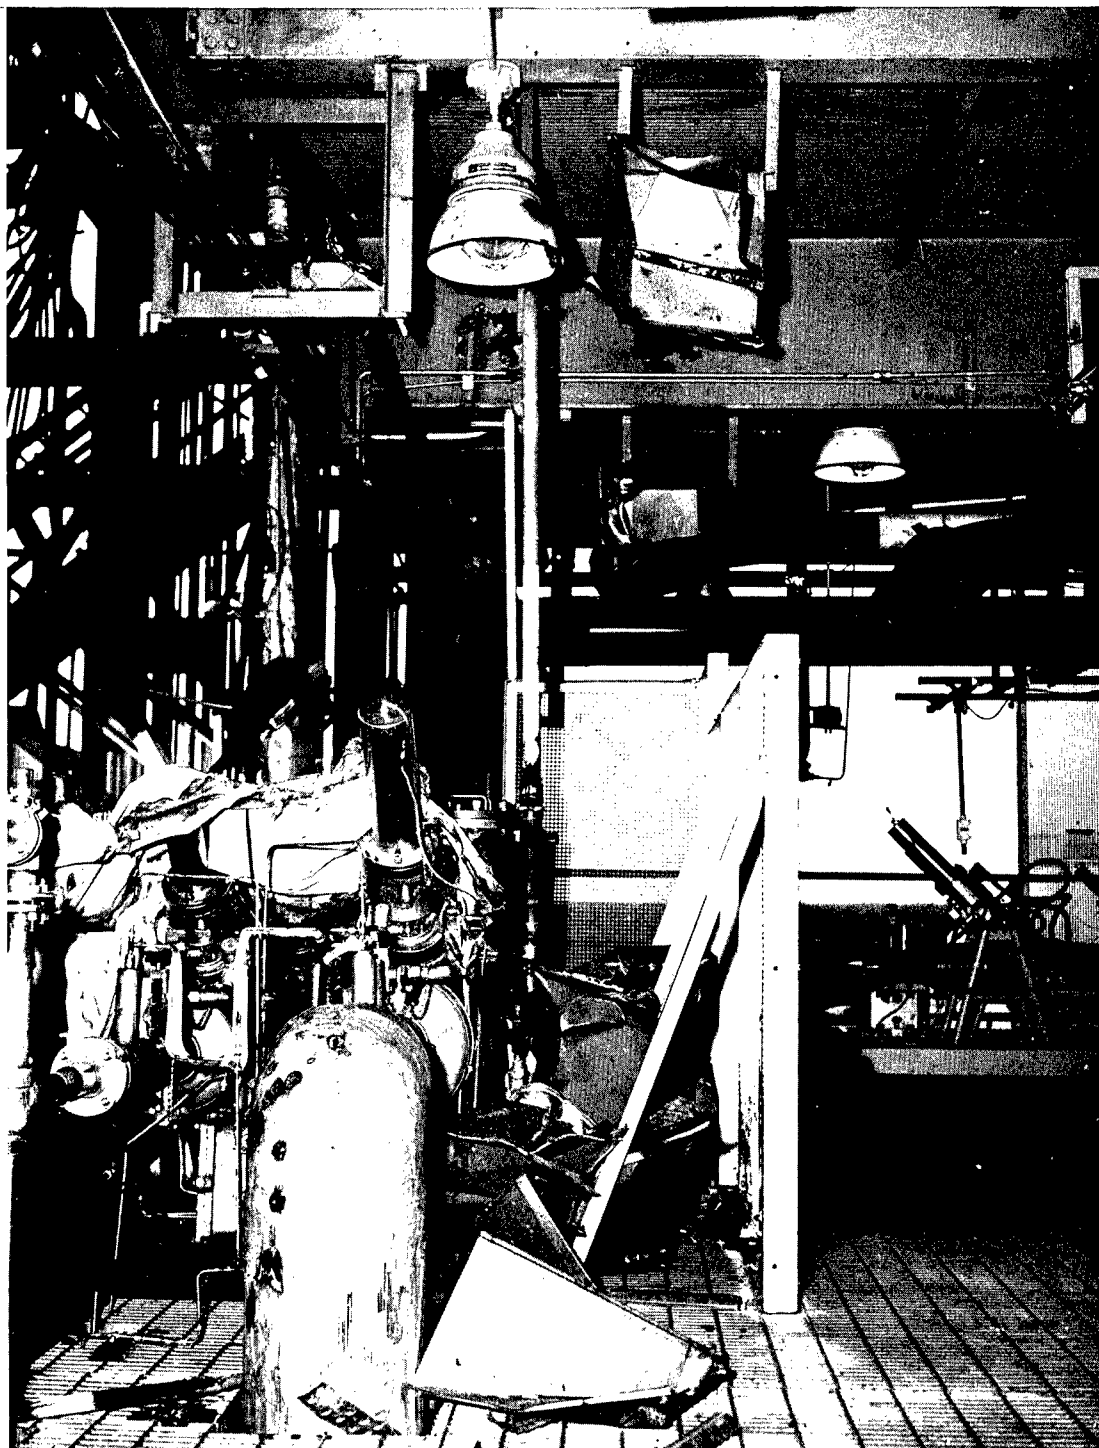
FIGURE 6. LIQUID HYDROGEN AND OXYGEN SLEDS (3rd LEVEL)

The liquid oxygen sled did not appear damaged. On the liquid hydrogen sled, flammable foam insulation was burned and valve handles were singed, but damage appeared inconsequential (FIG 6).

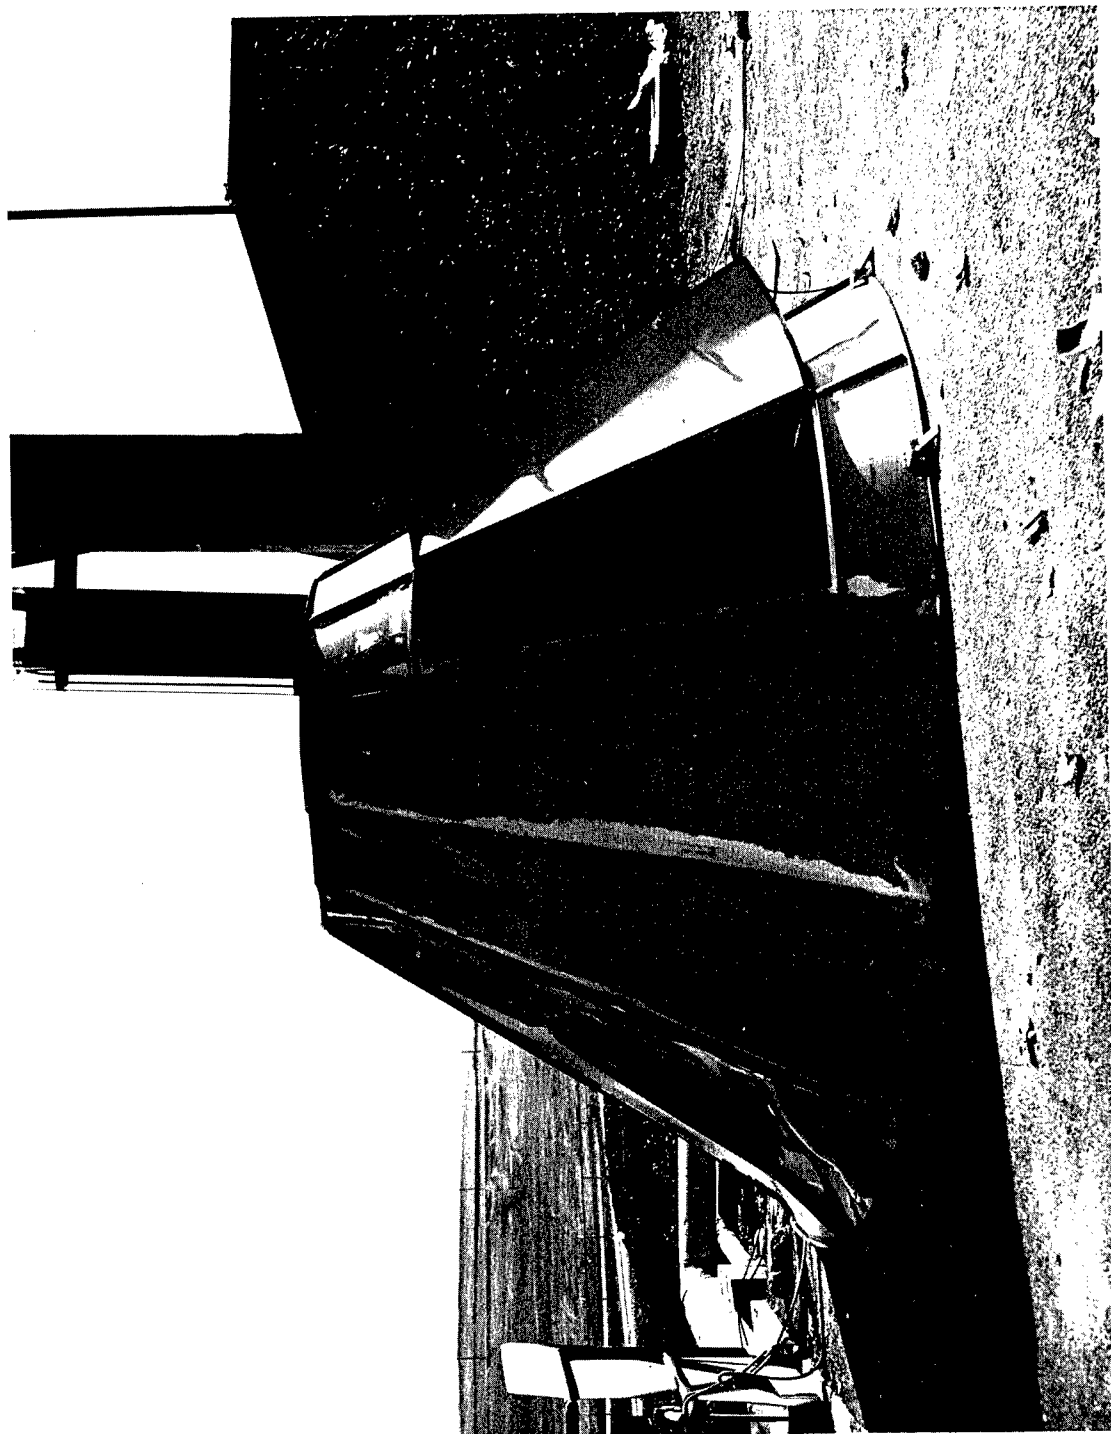
FIGURE 10. COVER PROTECTIVE ASSEMBLY

The Cover Protective Assembly was a truncated conelike structure (FIG 10) fabricated from aluminum, estimated to be approximately 1/16 inch thick. Its base diameter was 12 feet, and it tapered to a top-opening diameter of four feet. In all, there were 12 panels fastened to longitudinal stiffeners. The height of the structure was approximately six feet. The cover was positioned face down with its center 125 feet from a point on the ground beneath the explosion center. Permanent inward crushing, to a depth of six inches, was observed in several of the panels facing the blast.

The estimate of explosive weight required to produce such damage was made by using damage threshold curves similar to those given in BRL Memorandum Report 1461 but revised to include recent data. For analysis, the cover assembly was treated as a right circular cylinder with the following characteristics: length, 6 feet; diameter, 12 feet; skin thickness, 0.062 inch; material, aluminum. It was further assumed that the stiffeners increased by 10 percent the overpressure required for crushing. The analysis shows that an explosive charge of TNT weighing 1,200 pounds would be required to produce approximately the same degree of damage. The analysis also includes the assumption that the structure would have been in the Mach stem portion of the blast wave.
